12.2.7. Corrosion-erosion

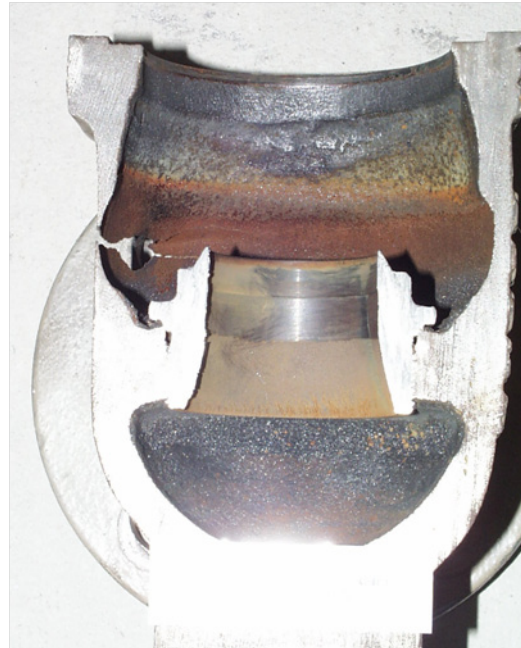
Figure 12.2.7.-1: Corrosion by a too high velocity of flow.

This attack by corrosion occurs especially on the inner walls and internal parts of control valves and is therefore often influential in the durability of a component or for the entire valve. If one examines this corrosion process more closely, one finds that insoluble corrosion products forming an oxide layer develop on the material surface. This layer causes a separation between the attacking fluid and the material. This normally very thin layer is designated as the „passivation layer“ which prevents or at least delays a further corrosion. For this reason, high quality austenitic steels are usually treated at first in a pickling plant before any further fabrication. In this passivation process old oxide layers along with scaling and iron dust are removed and a new, precisely controlled passivation layer is formed. It is obvious that this layer must not show cracks and must not be damaged, otherwise the corrosion attack will continue.

High flow velocities in the interior of the valve, fluids containing hard particles and cavitating fluids, however, permanently destroy this passivation layer, resulting in a gradually uniform surface corrosion of all parts. This finally limits the durability of certain parts or even the entire control valve. Because of the special importance of the valve trim with regard to characteristics and rangeability, a uniform material removal at the plug or seat ring is, of course, considerably more undesirable than a material loss of the body walls. This is also the major reason why for these trim parts a higher corrosion resistance and a better resistance against wear & tear is always required. A survey of corrosion types occurring most often in connection with industrial control valves and some of the remedies hereof are shown in Table 12.3.6.-1.
